MML TR-93-17

**Composite Panel Failure Analysis  
and Improvement Plan**

**U.S. Army Belvoir Research, Development  
and Engineering Center  
Fort Belvoir, VA 22060-5606**

**Martin Marietta Technologies, Inc.  
Martin Marietta Laboratories  
1450 South Rolling Road  
Baltimore, MD 21227-3848**

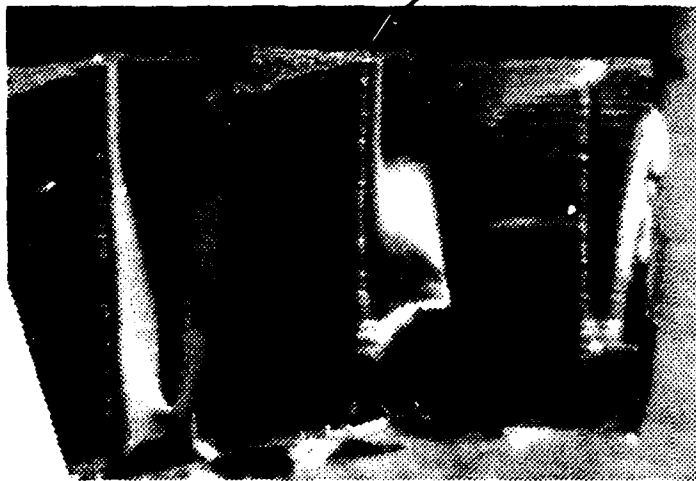
Core disbonds can be caused by contamination on the cell walls. However, most of the debonds seen on these specimens have an unusual feature in common. Figure 7 shows a side view macrograph of a cell wall taken from short beam specimen #4. Note that the adhesive fillet is not uniform in thickness across the cell. This pattern seems to persist throughout the region of core pull-out. Where the fillet is very small the applied stress necessary to initiate a failure is also small. Depending on the stress state of the bond, this can lead to bending of the cells, and a peel stress being applied to the thicker fillet, leading to pull-off. Non-uniform wetting of the core is unusual in my experience. The typical pattern seen in the short beam specimens is of a thin band or arc of asymmetric cells. These region probably represents an area where the core was slightly thicker, and was under higher stresses during cure, causing deformation that led to non-uniform wetting.

Figure 7. Edge of core near a pullout region. Note the very thin adhesive fillet along some portions of the core (arrow).

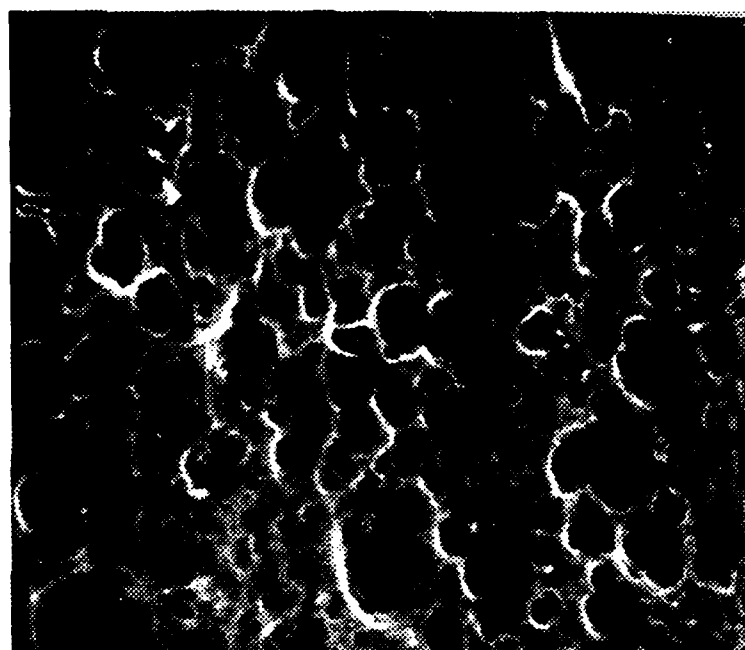
The electron micrographs of the surface analysis #1 specimen show a clean, complete break between the metal and adhesive side of the failure, Figures 19 and 20. In this case the metal side of the specimen shows distinct surface features, that are clearly replicated in the adhesive on the opposite side. The surface morphology is typical of an acid etched aluminum, with a pockmarked appearance. This surface is not typical of aerospace bonding practice, for it lacks the porous oxide layer that is receptive to adhesive infiltration and interlocking. This surface treatment should provide somewhat inferior dry bond strengths, but significantly reduced performance under high humidity conditions.

Figure 19. Electron micrograph of the metal surface of short beam specimen #2 in the slick-off region. The "lunar landscape" is typical of an acid-etched aluminum surface.

Figure 20. Electron micrograph of the adhesive surface opposing the metal shown in Figure 19. The surface exactly replicates the details of the metal side.

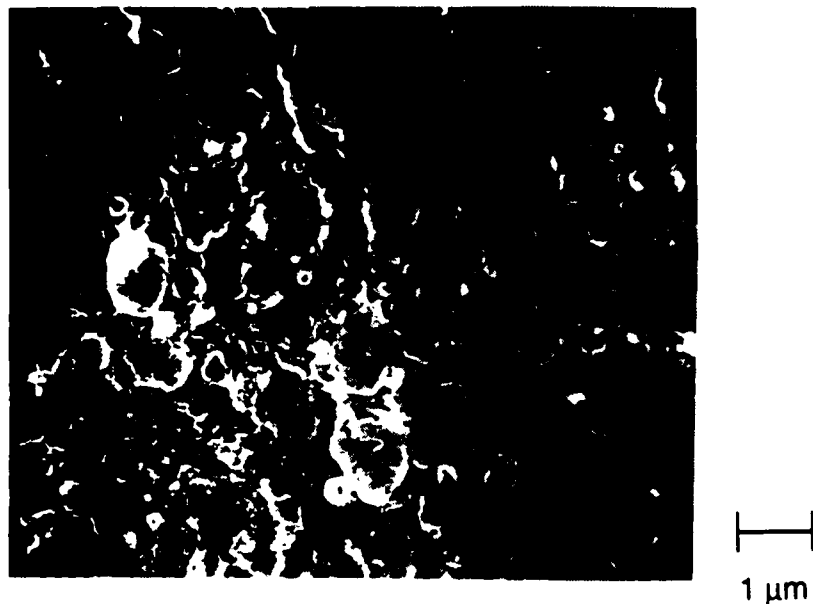
The surface morphologies seen on the other four specimen surfaces are essentially identical, Figures 23-26.. In these cases the same pockmarked metal-side surface is seen, but the features are less distinct. The smoother edges, and slightly bumpy surfaces indicate that an extremely thin layer of adhesive is still clinging to the metal surface, and the failures in these cases are actually entirely within the adhesive (cohesive), rather than strictly interfacial.

Figure 23. Electron micrograph of the skin surface of static edge specimen #2 in a slick-off region. In this case the etched aluminum morphology is covered by a layer of adhesive.

Figure 24. Mating surface of figure 22. Here the surface reflects the rougher, cohesive failure surface of the metal side.

Figure 25. Electron micrograph of the skin surface on the type I panel in a slick-off region at the edge (part of the tail from the central slick-off). The etched surfaced appears to be coated with a light layer of adhesive.

Figure 26. Electron micrograph of the adhesive mating surface of the edge of the type I panel. This surface lacks the sharp-edged features of true replicas, indicating a cohesive rather than interfacial failure. DSC of adhesive material taken from this region indicate lack of cure, which would explain a cohesive failure.

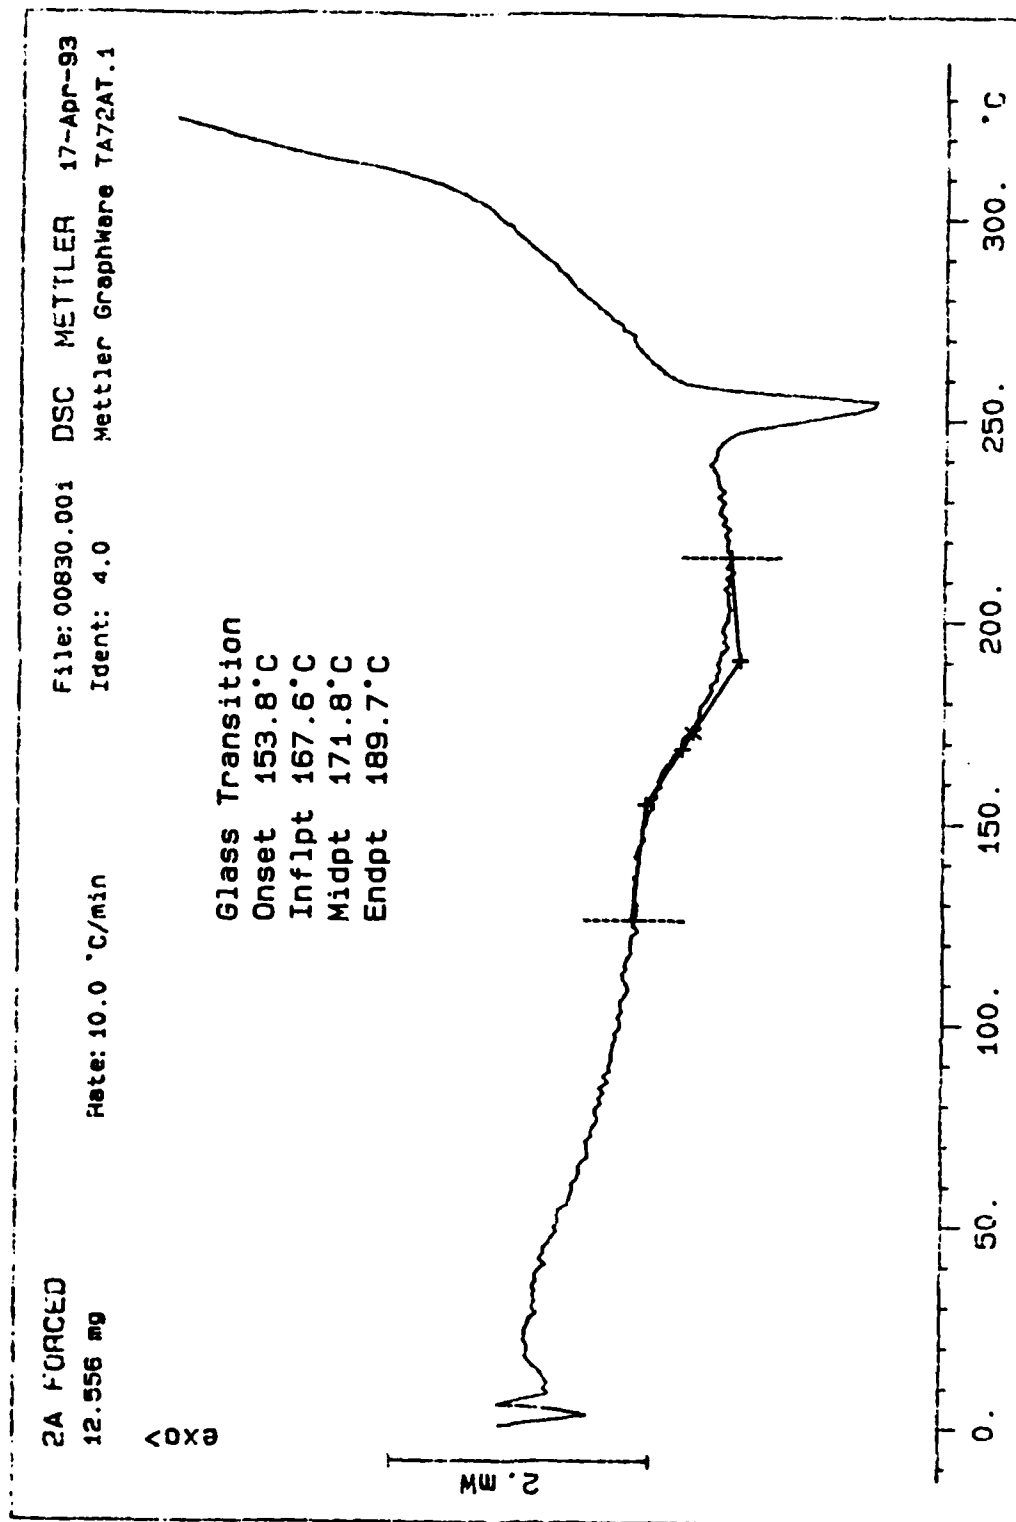
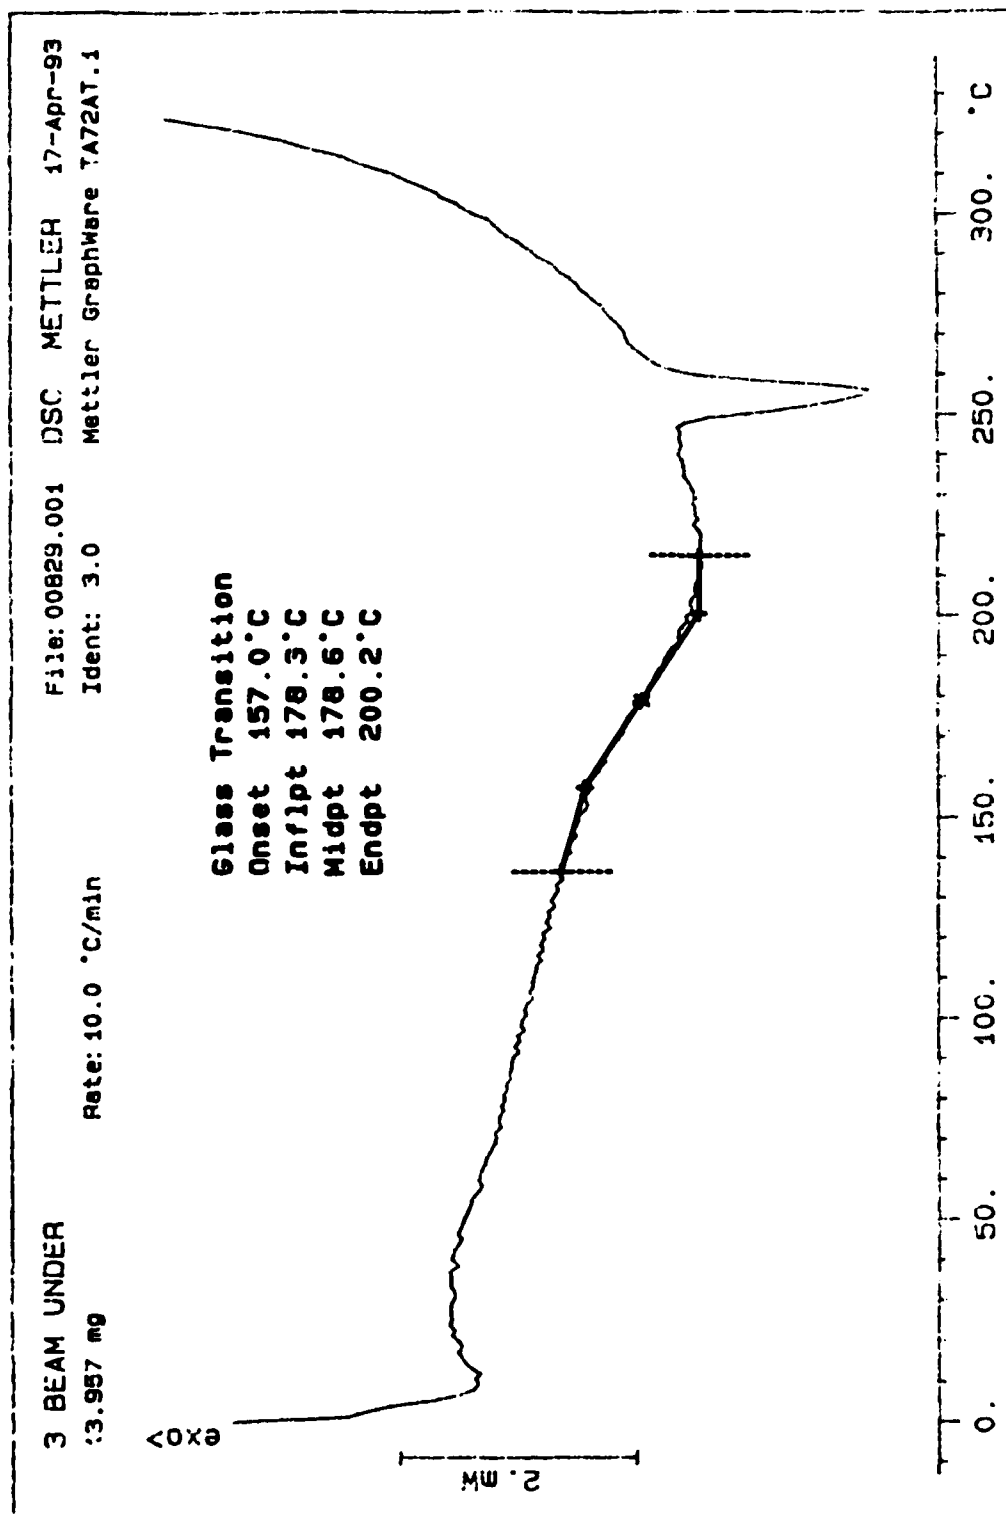
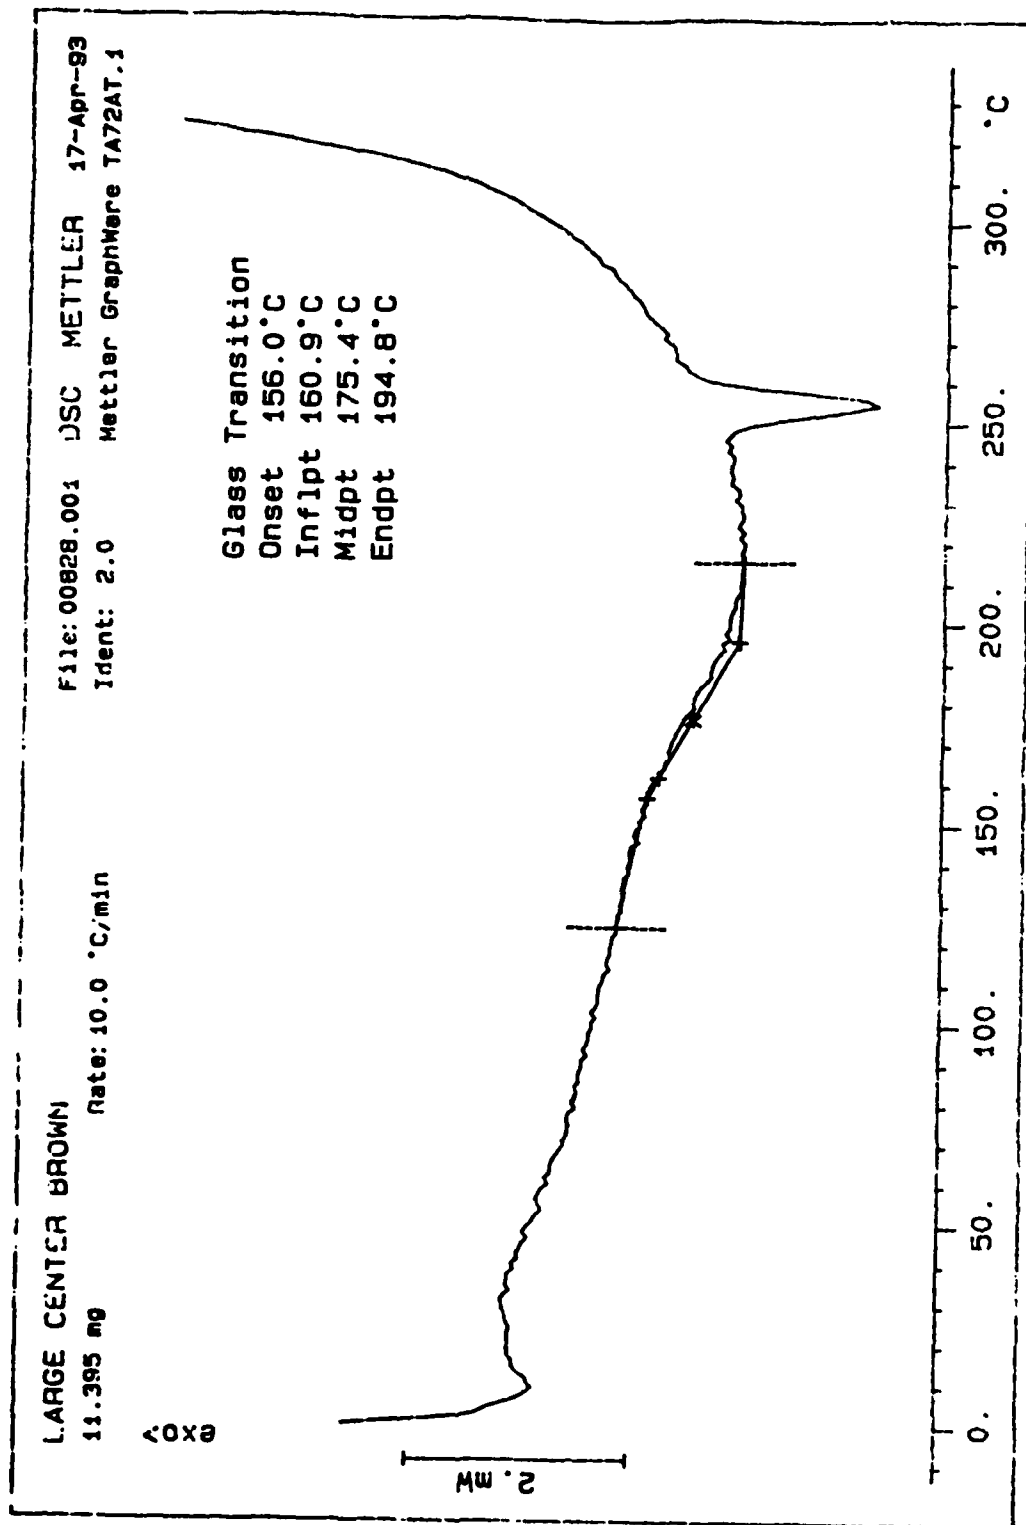
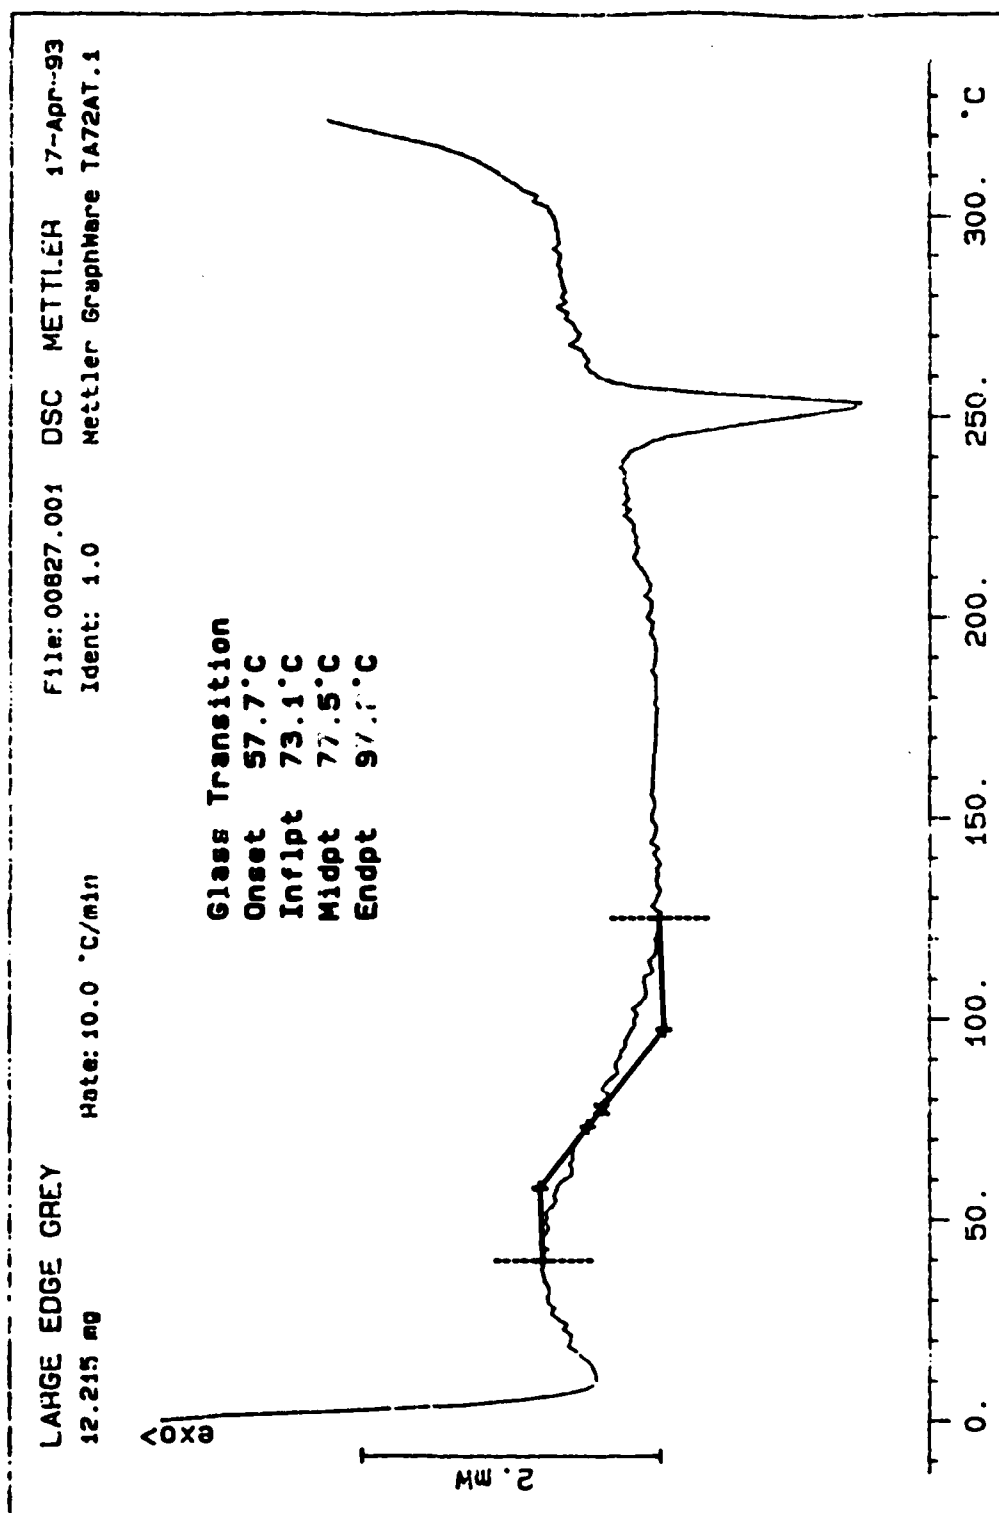
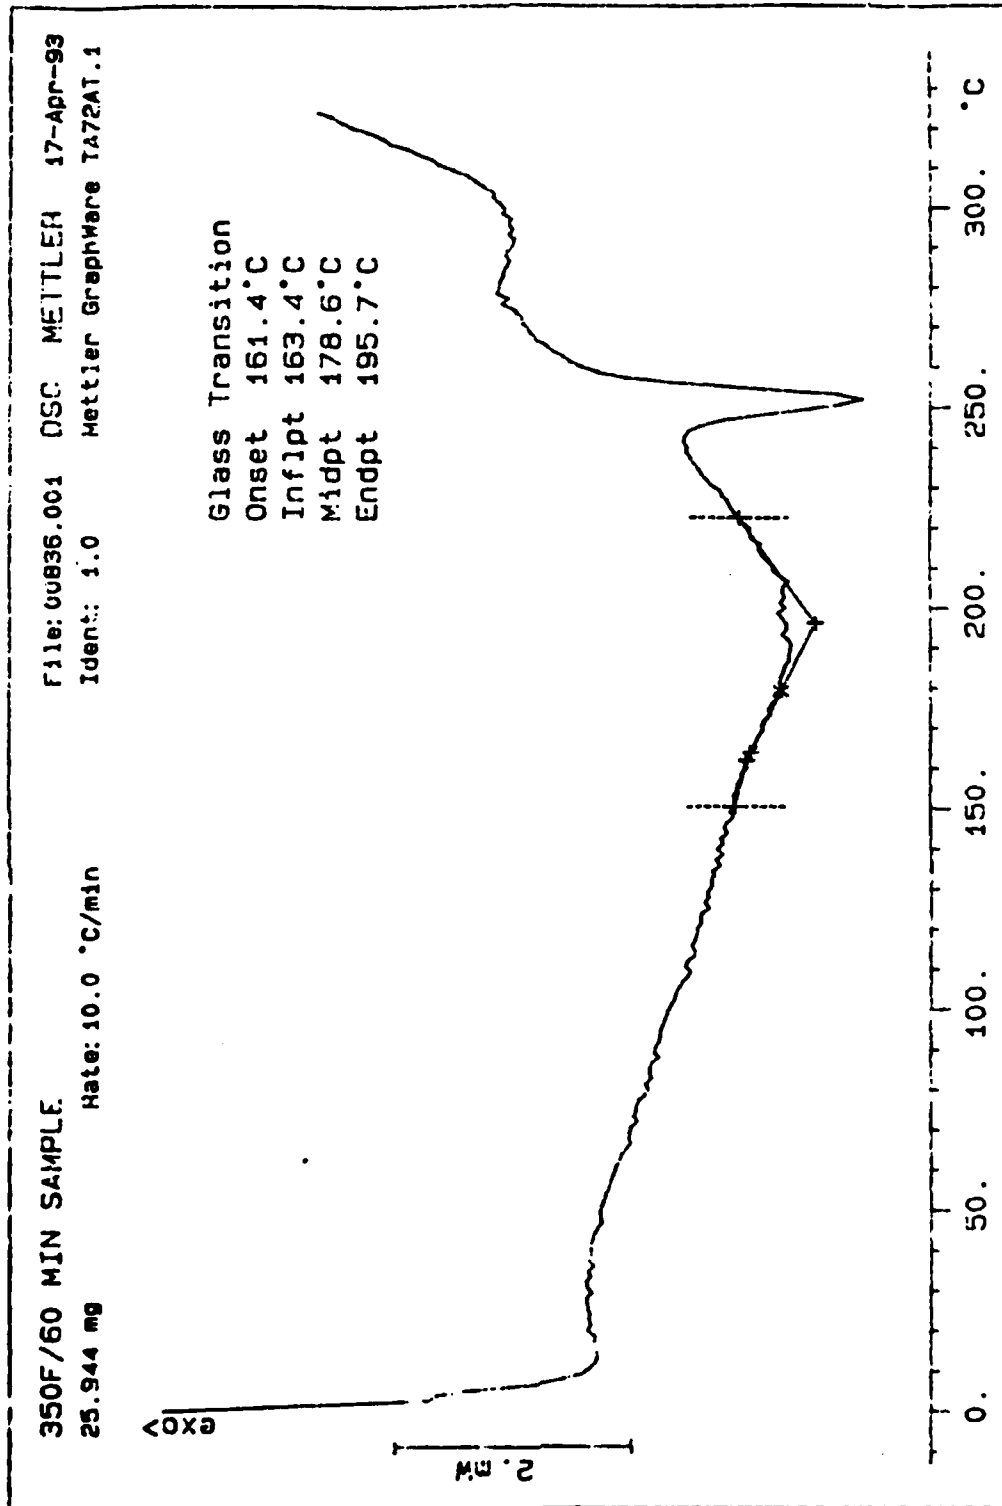
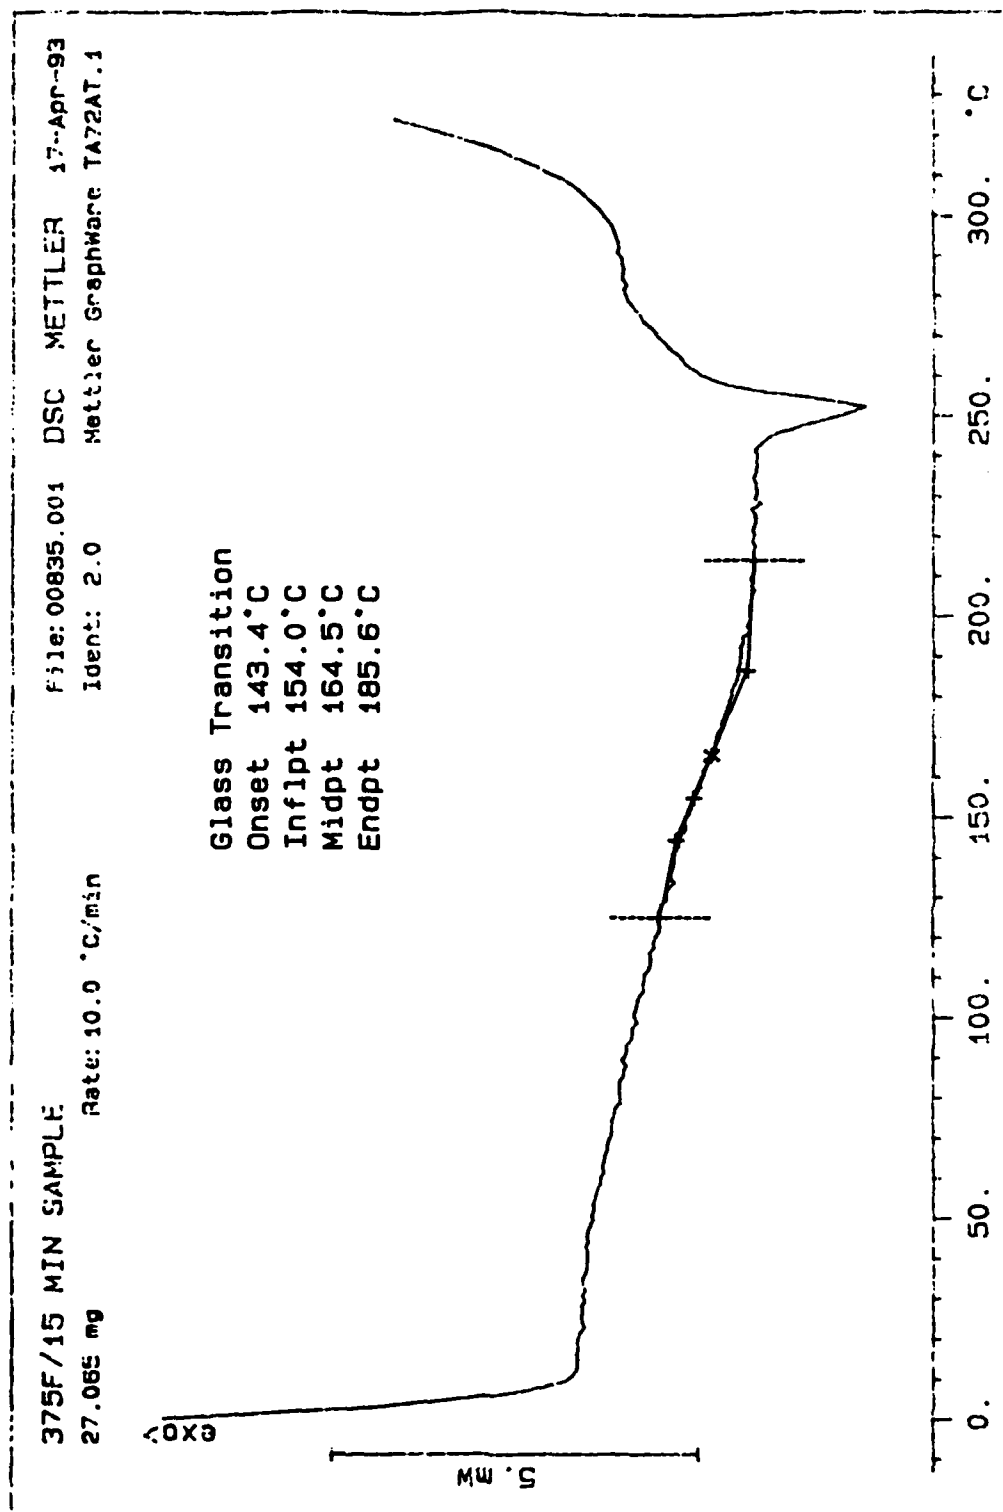
We used DSC to determine the glass transition temperatures of adhesive taken from various sample locations. This value is a measure of completion of cure, i.e., more completely cured adhesives will have higher  $T_g$ s. Table VI. shows the results of this study, along with samples of fresh adhesive cured according to the recommended schedule, and the modified schedule used in construction. Figures 27-32 show the actual DSC curves for the six specimens.

These results raise a number of interesting points. First, the recommended cure seems to be somewhat more complete than the production cure schedule. When this adhesive is cured in air at higher temperatures (>375 $^{\circ}$ F) the outer surface turns brown. Thus the two specimens with dark surfaces have reached higher temperatures. They also show higher than average  $T_g$ s, although they do not exceed that of the recommended cure material. In general, the differences between the various samples are small, except for the Type I panel edge. The very low  $T_g$  seen here is more typical of the uncured adhesive. This indicates that the control of temperature distribution over the surface of the panel specimen was very poor, with one portion in the center melted by the heat, but another at the edge almost uncured.

Figure 27. DSC trace of a piece of adhesive removed from short beam sample #3.

Figure 28. DSC trace of a piece of adhesive removed from short beam sample #6

Figure 29. DSC trace of a piece of adhesive removed from the center of the type I panel (brown).

Figure 30. DSC trace of a piece of adhesive removed from the edge of the type I panel (slick-off).

Figure 31. DSC trace of adhesive that was cured for one hour at 350°F.

Figure 32. DSC trace of adhesive that was cure for 15 minutes at 375°F.

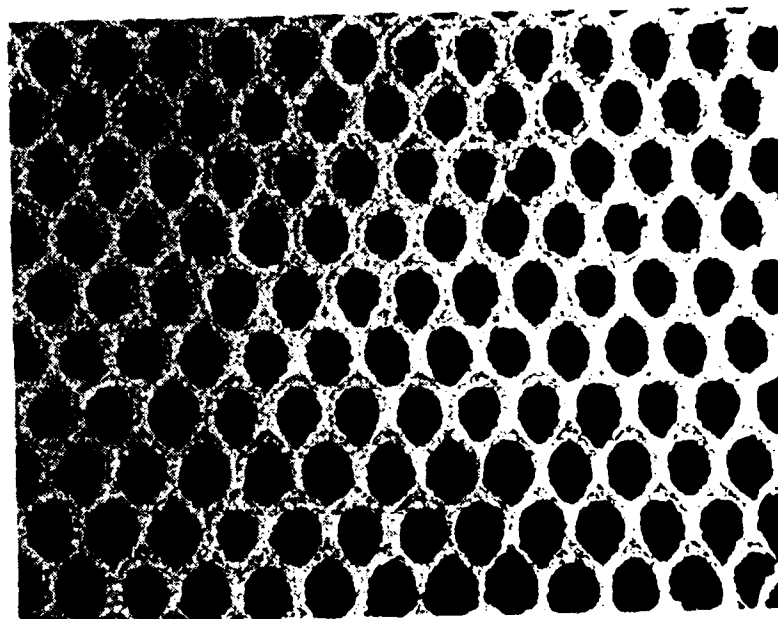
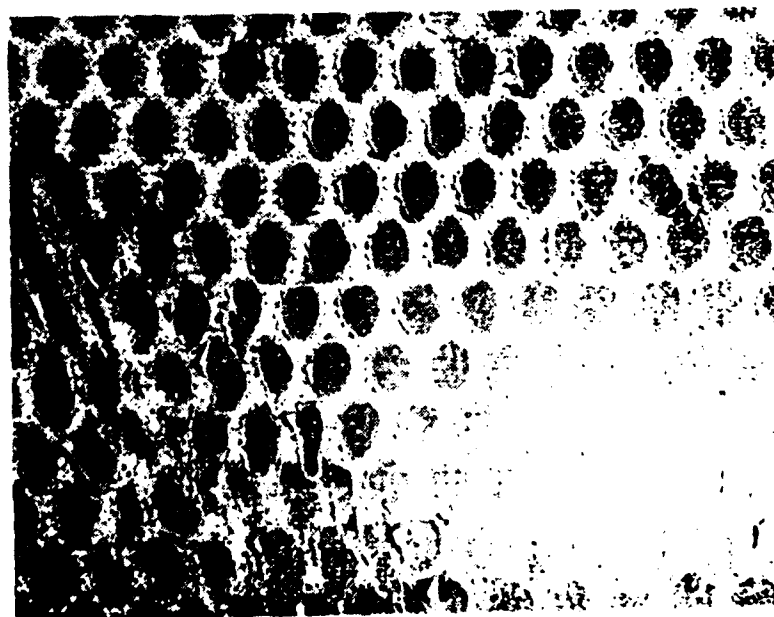
significant amount of adhesive still adhering to the core, and the clean appearance of the part of the skin where the adhesive was pulled off. This test indicates that the cure procedure is not the immediate cause of poor skin to core bonding.

Figure 33. Macrograph of the core of the 375°F-cured test sample. Note the extensive adhesive fillet on all edges of the core.

Figure 34. Macrograph of the skin side of the 375°F-cured test sample. Support fibers can clearly be seen in regions where the honeycomb pulled off adhesive.

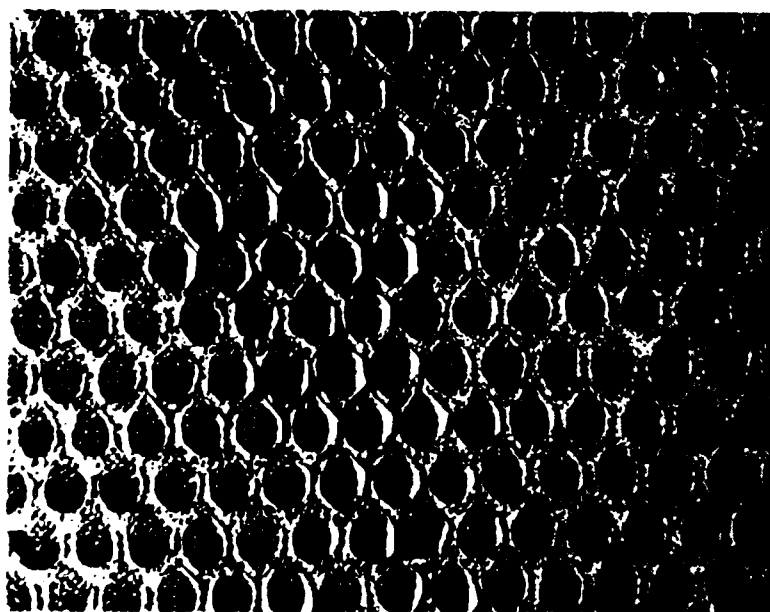
Contrast the surfaces of short beam sample #6 shown in Figures 35 and 36 with those of the test specimen. A band of core pull-off cells can be seen in the center of the macrographs, but even in the relatively well bonded regions at either side the amount of adhesive remaining on the core is much less than that seen above. In addition, the areas on the skin where the core pulled off the adhesive show much more remaining adhesive; the support fabric clearly seen in the test specimen skin photos is completely obscured by an adhesive layer here. This specimen had a backside skin failure and showed core buckling. Similar macrographs from a v-notch, top skin failure show exactly the same features, Figures 37 and 38. These features are not directly related to the cure schedule used, but must reflect another deficiency in bonding practice, namely inadequate pressure to force the core into the adhesive..

The other problem related to pressure was seen in the general core to skin bonds. None of the core seemed to be sufficiently pressed into the adhesive to make normal fillets. As Figure 36 shows, the average panel core to skin bond showed considerably more adhesive underneath the honeycomb, and less in the fillet, than would be expected using standard methods. This would significantly reduce the strength of this bond, and lead to the marginal failures observed in the short beam testing. It appears that the overall pressure used to bond the mats was insufficient. Although the FPS para. 3.13 states that 35 psi should be applied to the platens, the bondments indicate that the actual pressure was lower. This certainly should be checked in the future.

Figure 35. Macrograph of the core side of short beam sample #6. Relatively little adhesive remains on the core.

Figure 36. Macrograph of the skin side of the short beam sample #6. Adhesive still coats the support fibers under the core imprint.
